Docket No. 217 – Development and Management Plan Inspection

Northeast Utilities Service Company Certificate of Environmental Compatibility and Public Need for the construction of a 345-kV electric transmission line and reconstruction of an existing 115-kV electric transmission line between Connecticut Light and Power Company's Plumtree Substation in Bethel, through the towns of Redding, Weston, and Wilton, and to the Norwalk Substation in Norwalk, Connecticut.

Date: August 25, 2005

Location: Transition Stations (Hoyts Hill, Archers Lane)

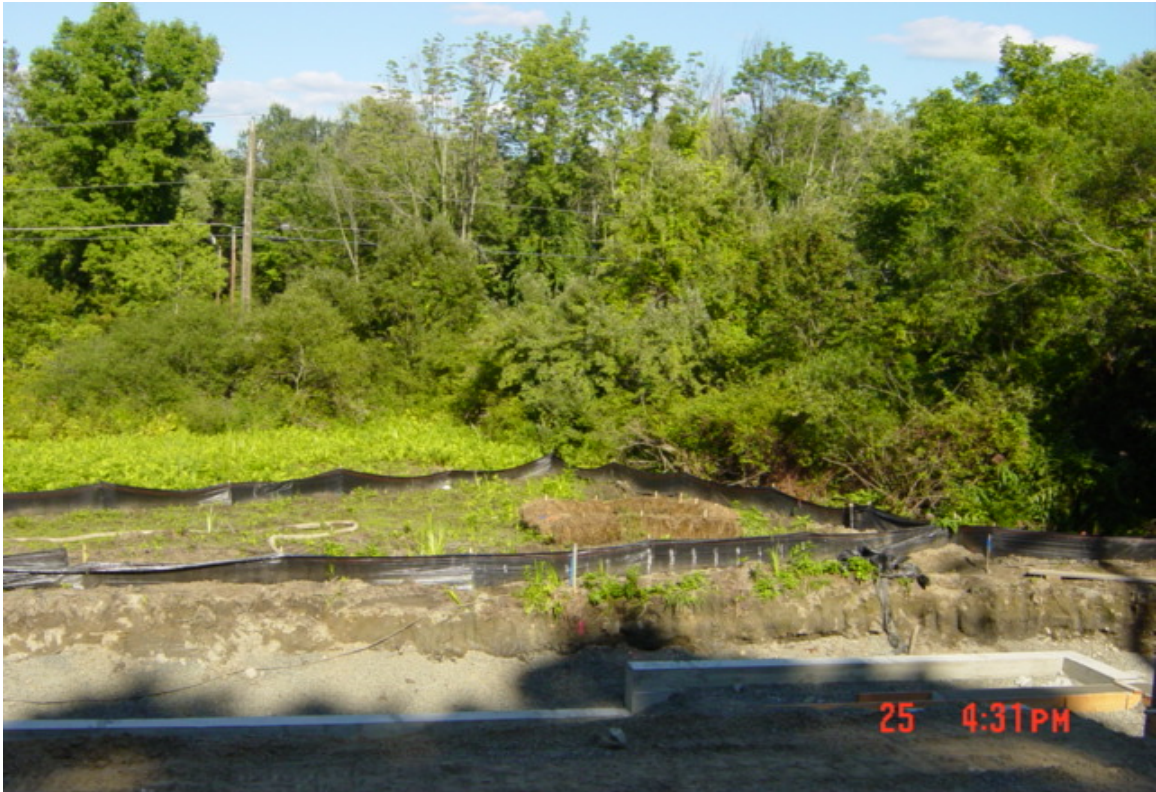
Hoyts Hill Transition Station: Overall view of the site and the erosion controls remain in good condition. (8/25/05)

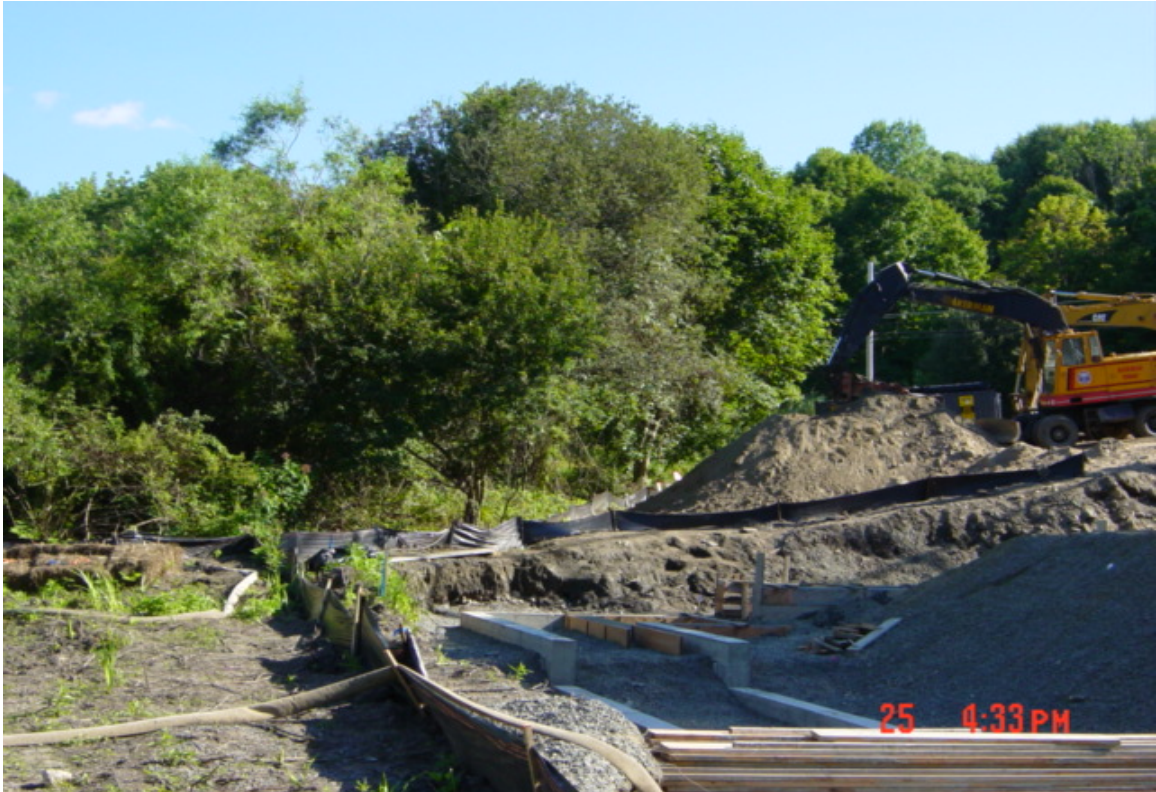
Overall view of the earthwork occurring at the site and initial foundation work. (8/25/05)

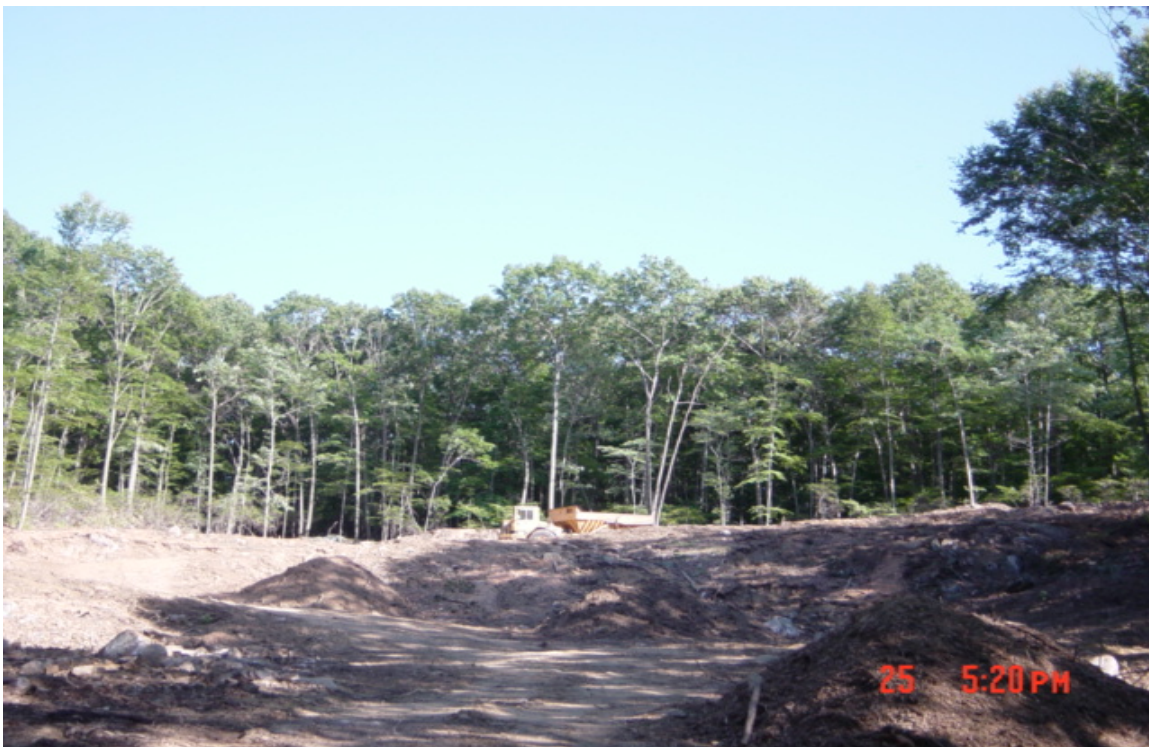
Archers Lane Transition Station: Overall view of the area cleared for the transition station site. Silt fence is now installed. (8/25/05)

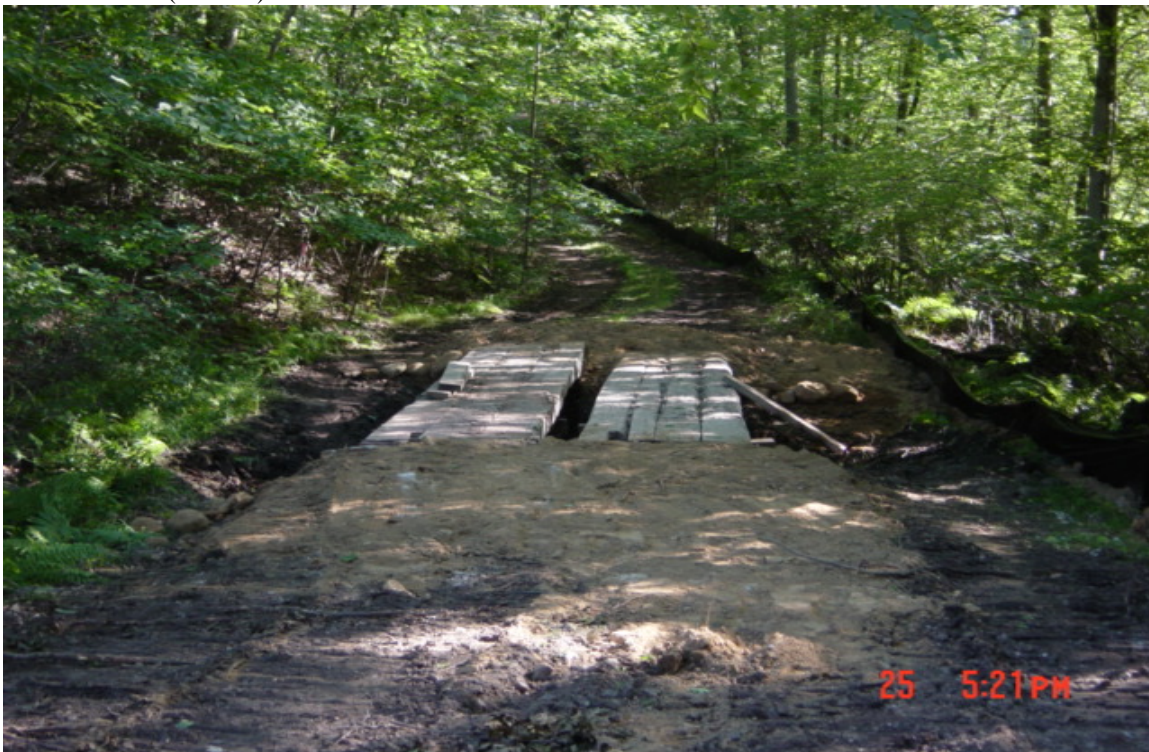
View of the crossing installed to span the potential wetland spot within the woods access road. The crossing should remain in place for the remainder of the work and the soil surface below should be reseeded. (8/25/05)
